New York State Department of Transportation

Yellow Flag NB22CTW006

BIN: 1065318

Location: Span 130 Girder G15 at Pier 129

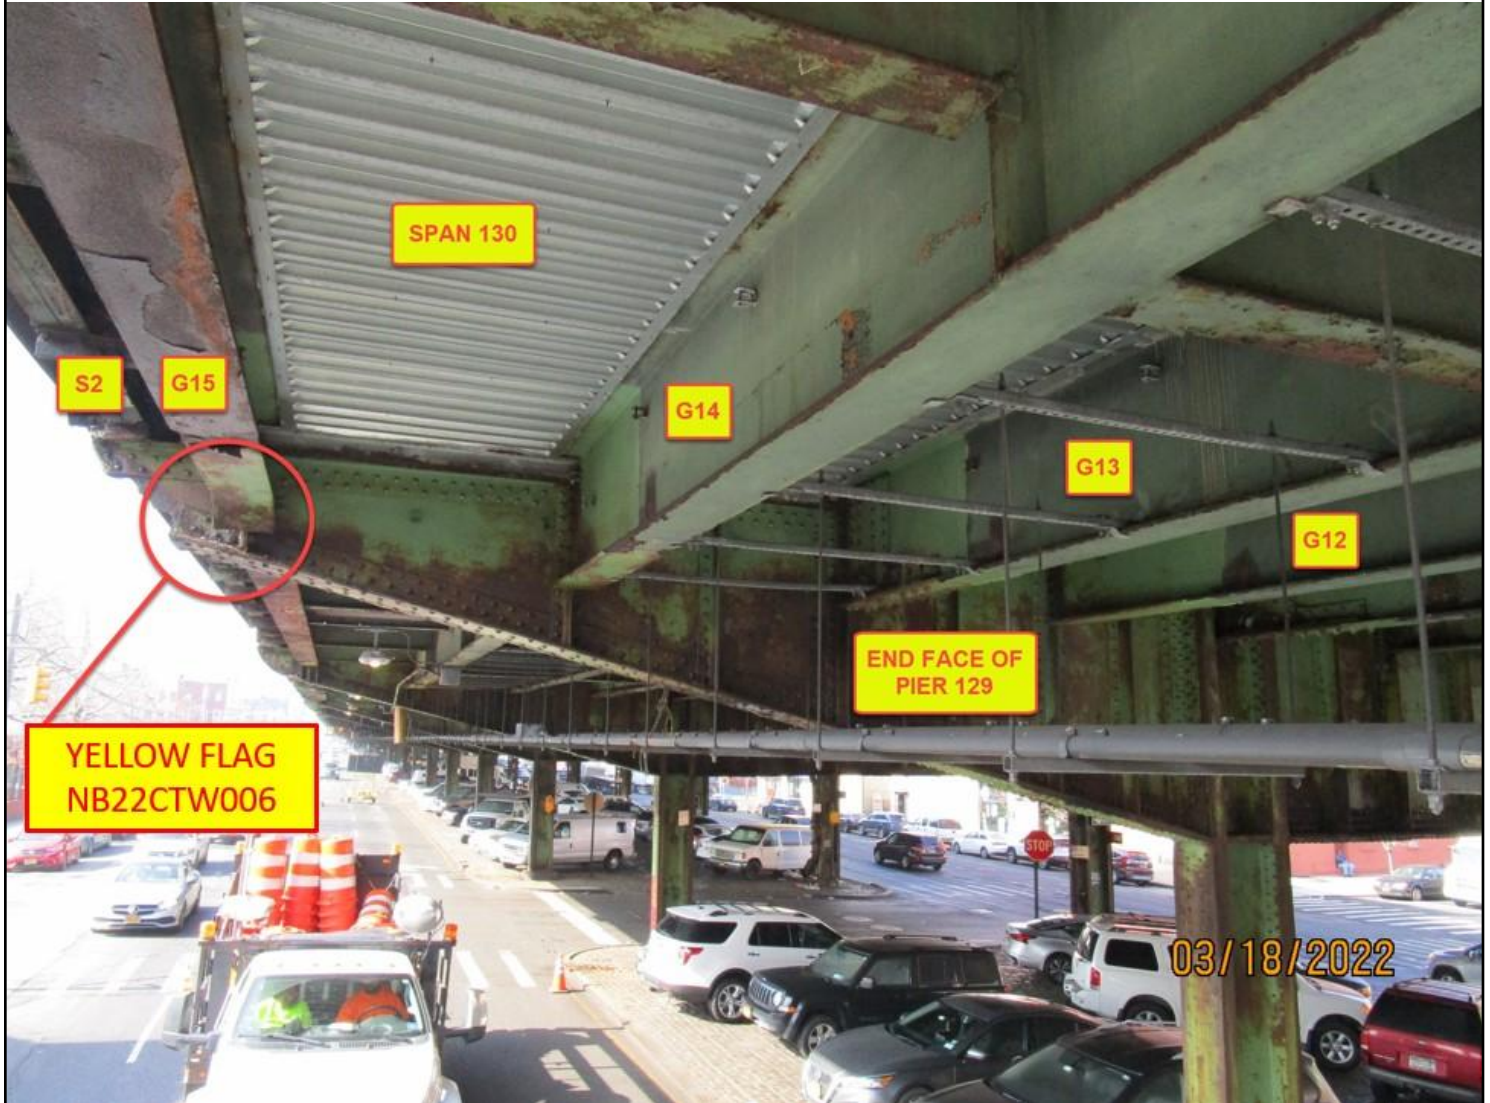
Photo Number: 1

Attachment Description: General view of the flagged condition at Girder G15 in Span 130 at Pier 129. Looking Begin.

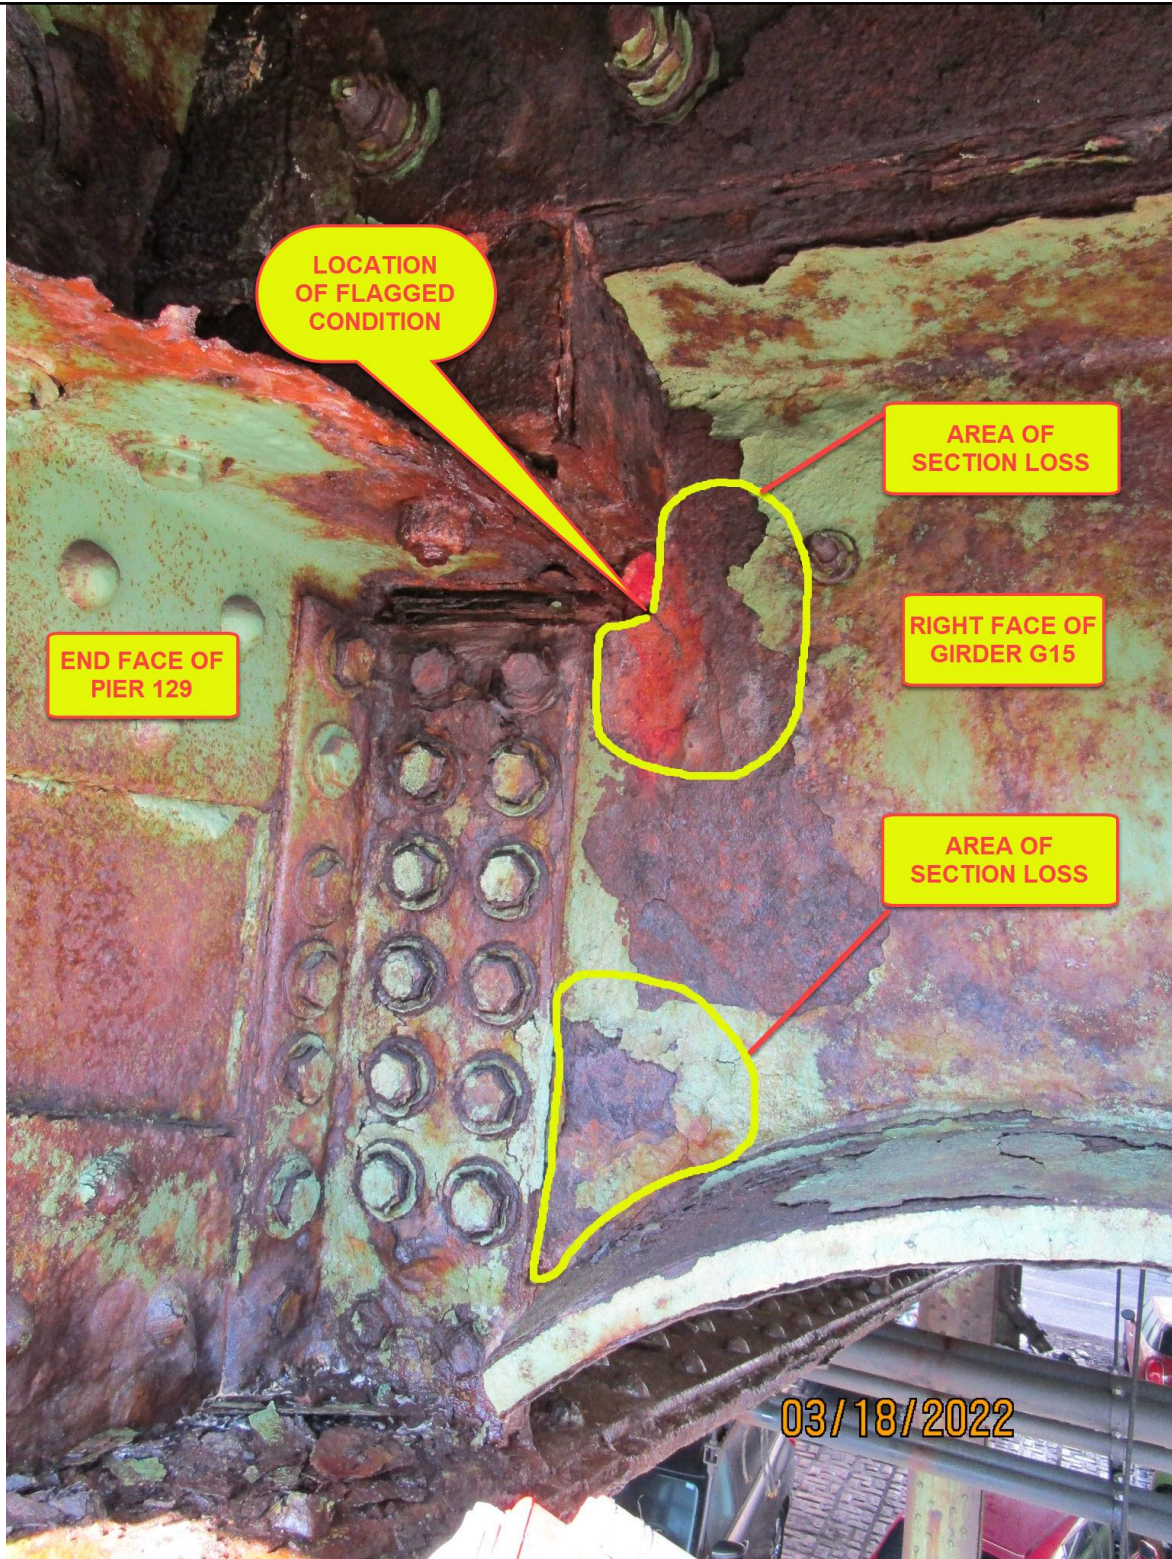
Photo Number: 2

Description: The end of Girder G15 in Span 130 at Pier 129 exhibits a 1-1/4" long (previously noted 1-1/8" long) diagonal crack in the girder web stemming from the top of the top cope of the girder (Photos 2 and 3). The girder is framed into the web of the pier.

1. Girder G15 exhibits 30% section loss at the upper web at the top cope for 4"H x 4"W area and 20% section loss at the lower web at the bottom cope for 10"H x 5"W area (Photo 2). The condition is the same as reported in the last inspection.

Attachment Description: The right face of Girder G15 in Span 130 at Pier 129. The upper web of the girder exhibits a diagonal crack at the top cope with section loss at the upper and lower web of the girder. Looking Left.

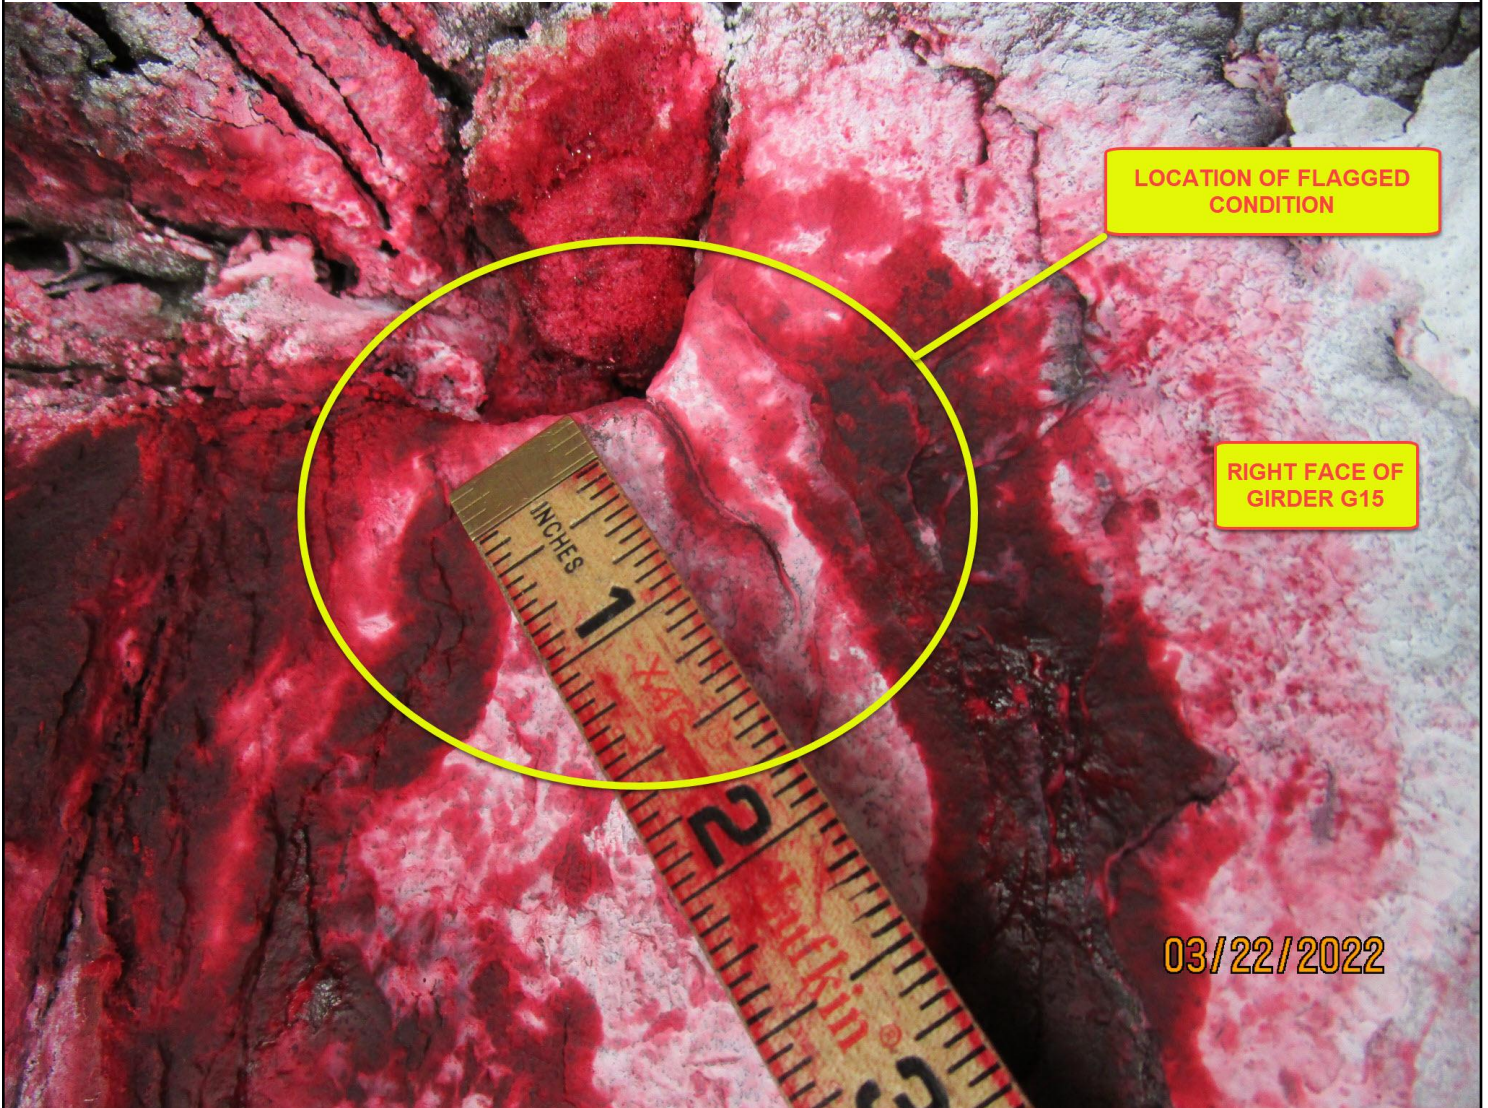
Photo Number: 3

Attachment Description: Close up view of the right face of Girder G15 in Span 130 at Pier 129. The upper web of the girder exhibits a diagonal crack at the top cope. Looking Left.

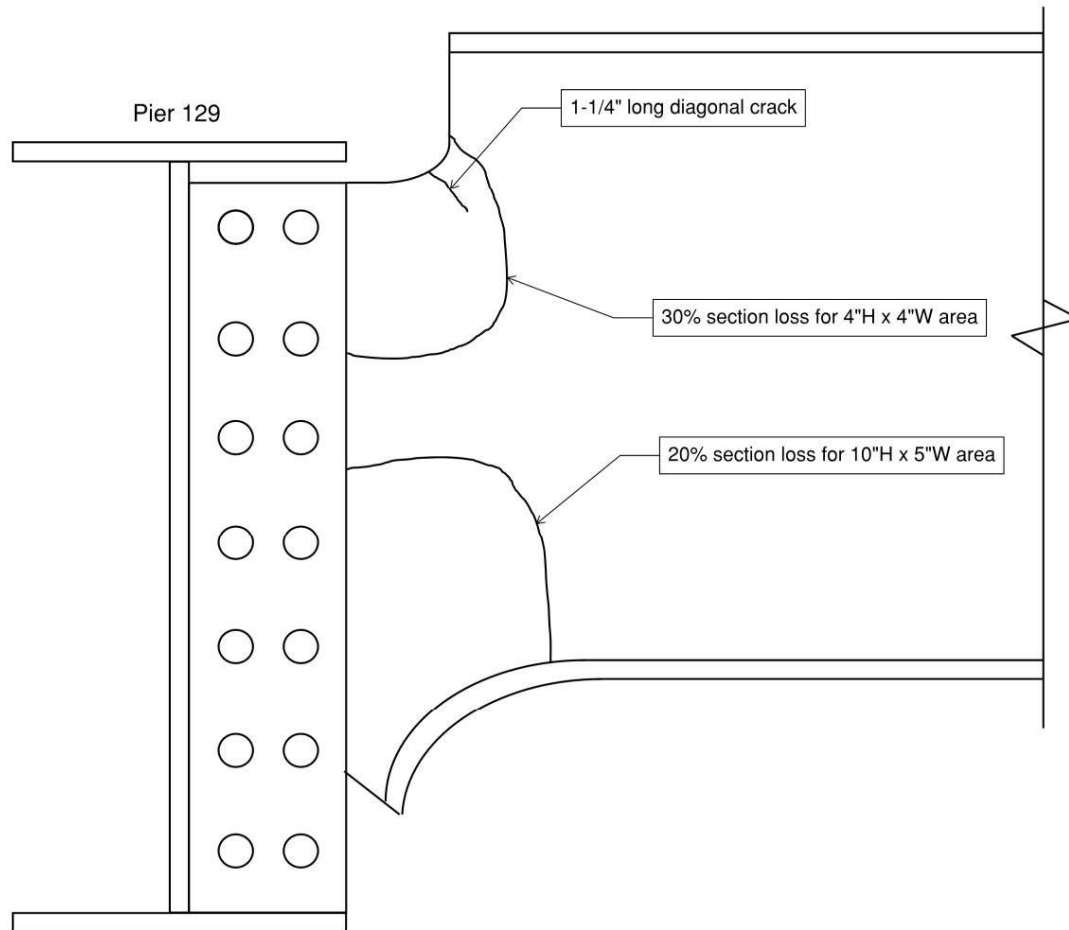
Photo Number: **4**Photo Filename: **22YF_Span 130_G15 Sketch.jpg****Right Face of Girder G15 Sketch in Span 130 at Pier 129**

**Attachment Description: Span 130 G15 at Pier 129 Sketch**

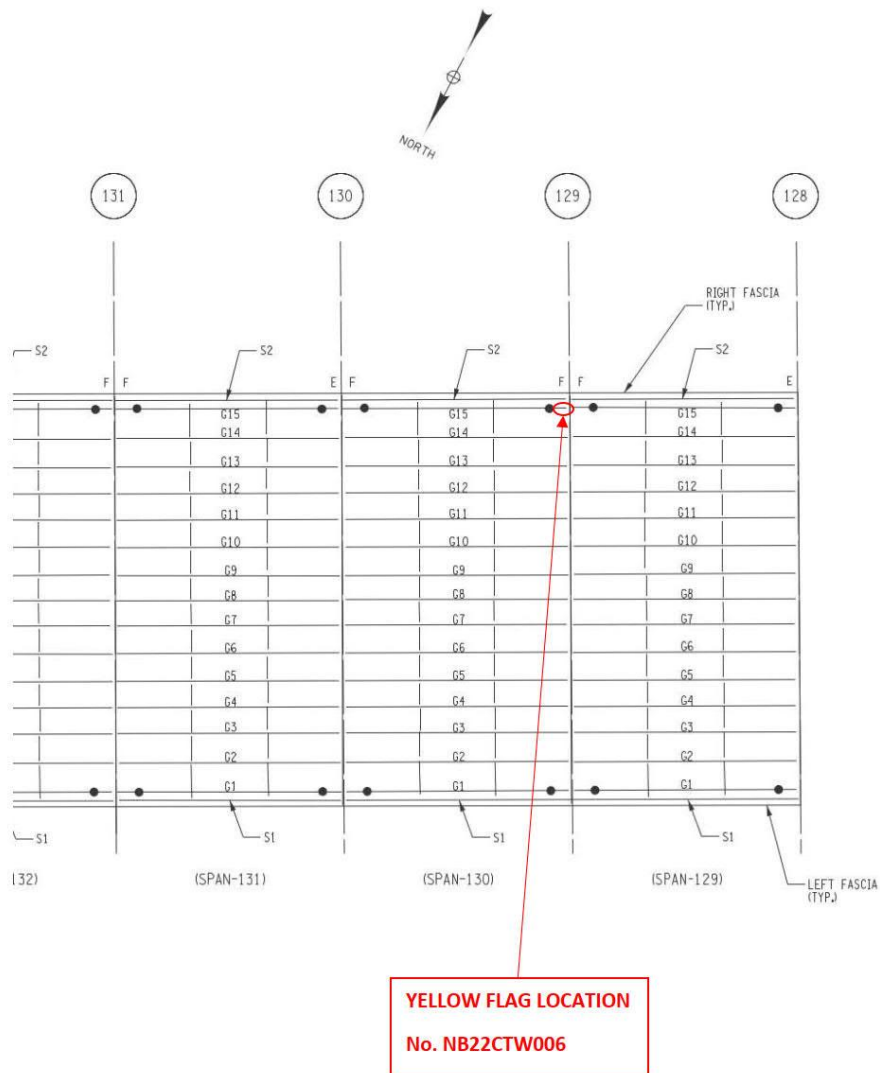
Photo Number: 5

Attachment Description: Span 130 G15 at Pier 129 Framing Plan
